**The Comparison of Animal Detection Systems in a Test-Bed:  
A Quantitative Comparison of System Reliability and Experiences  
with Operation and Maintenance**

**Final report**

April 23, 2009

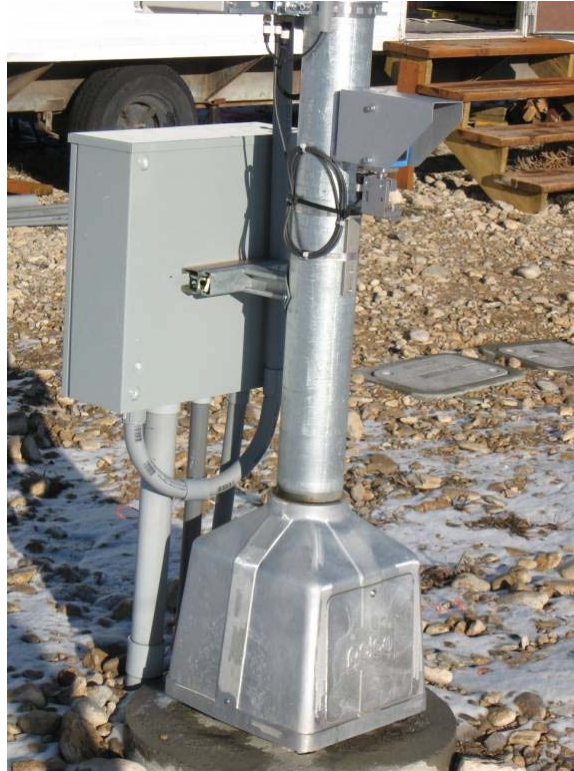
Figure 3.10: System 5 (Calonder Energy 1) (Photo: Marcel Huijser, WTI/MSU).

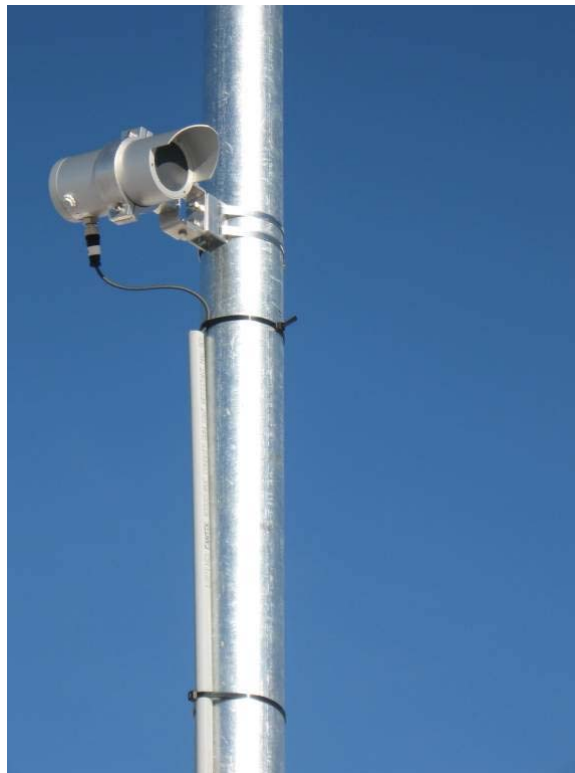
Figure 3.11: System 6 (Calonder Energy 2) (Photo: Marcel Huijser, WTI/MSU).

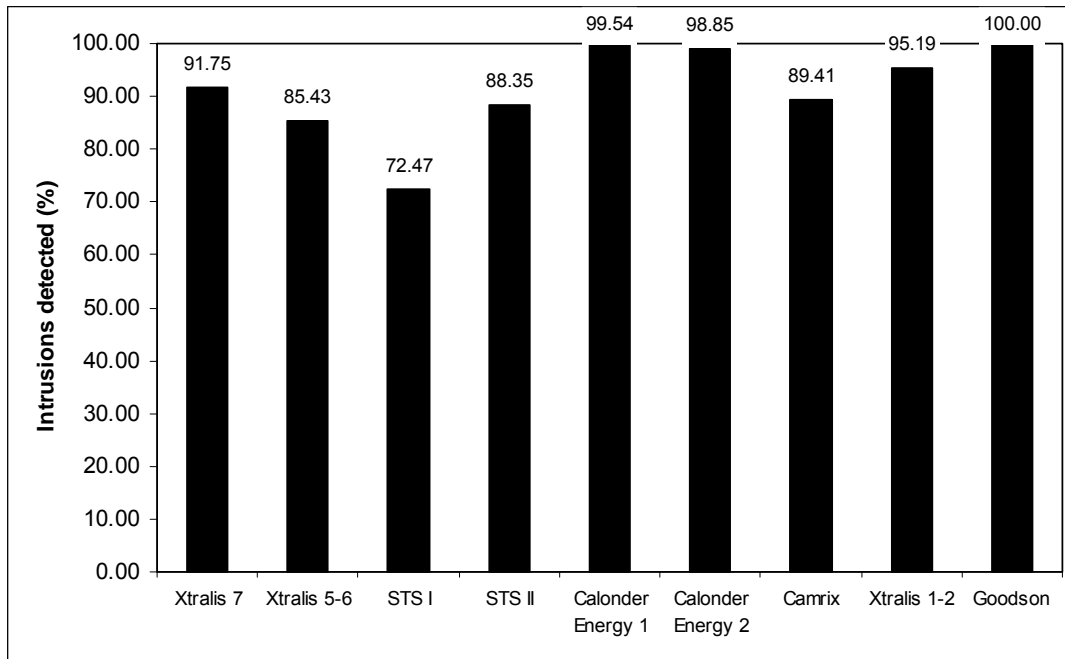
Figure 4.6: The percentage of intrusions that were detected for each system (Camrix: before (89.33; additional analysis 81.82) and after (90.24; additional analysis 75.51) system modification).

The following systems detected all or nearly all intrusions (i.e., animal movements across the detection line): Goodson, Calonder Energy 1, and Calonder Energy 2 (Figure 4.6). STS I showed the lowest detection percentage (Figure 4.6). For Camrix an additional analysis that included the detection area (see section 5.3) showed this system detected 81.2 percent of all intrusions in the detection area.

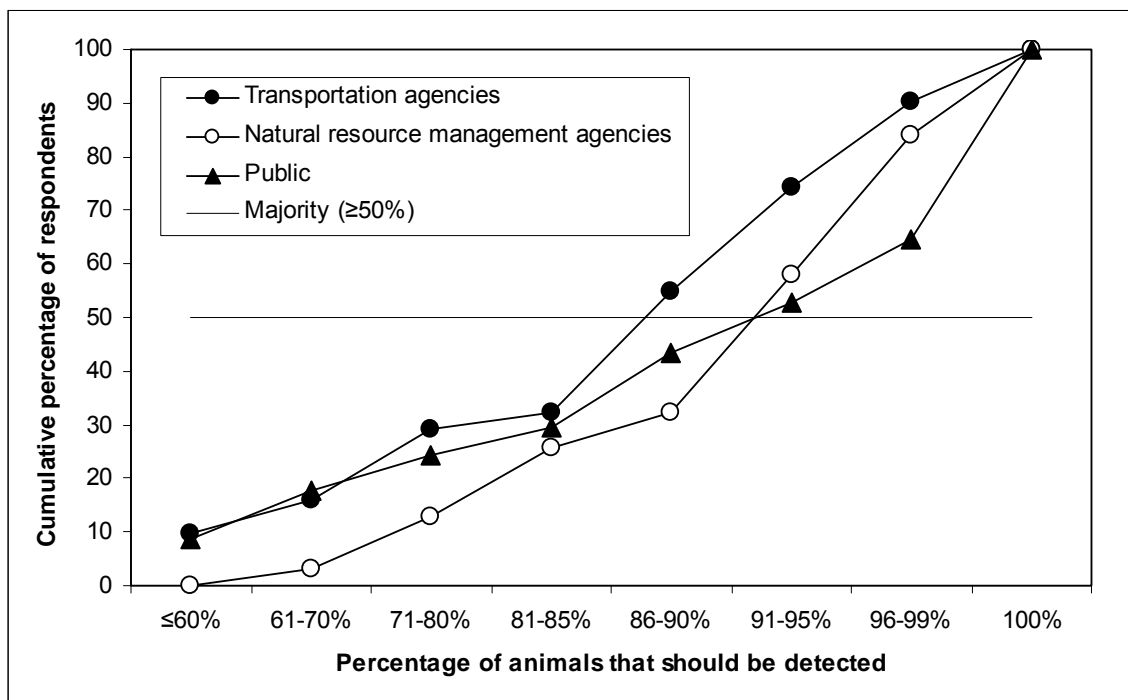
Figure 8.2: The percentage of large animals approaching the road that survey respondents said should be detected by animal detection systems. The number of respondents included in the analysis was 31 for transportation agencies, 31 for natural resource management agencies, and 136 for the public.

The majority ( $\geq 50\%$ ) of all three stakeholder groups would be satisfied with animal detection systems detecting 91–95% or more of all large animals that approach the road (Figure 8.2).
